Electrical Noise in Battery Installations

Zbigniew Noworolski, PhD, P.Eng.; Ulo Reskov

Polytronics Engineering Ltd, Toronto, Canada

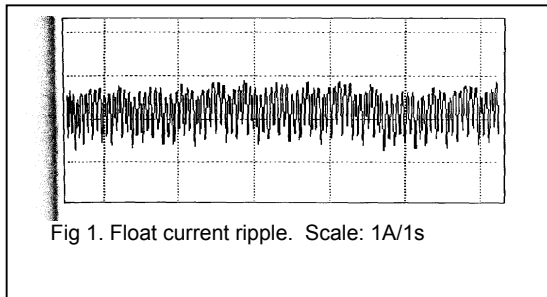
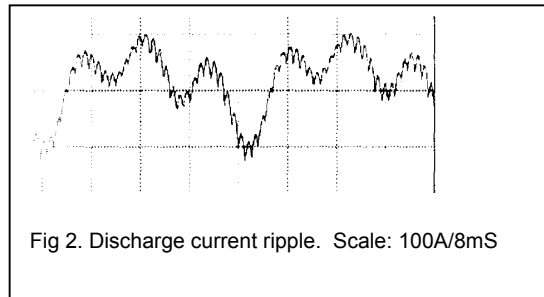
The best example of a ripple free installation is the telecommunication system demanding a well-filtered DC power source. On the other end of the scale are UPS and Electrical Vehicle (EV) applications. Since the battery is part of a larger system in which only system parameters are specified, the designers of UPS systems often take the liberty to use the battery not only as an energy storage device, but also as a large capacitor bank. As a result, in some UPS installations the ripple current might reach unexpected high values. We have observed as much as 380 A of ripple current during a 1100 A discharge. The shape and amplitude of ripple currents vary greatly from site to site depending on the type of equipment connected to the battery. Some example waveforms captured during normal operation and discharging are presented in the figures above.

This is usually produced by the mutual interaction of the rectifier and the inverter connected to the battery. If the battery is connected directly to the equipment's DC bus, the ripple AC current will flow through the battery. The magnitude of ripple currents in the battery installation depends primarily on the existence and type of DC load [1].

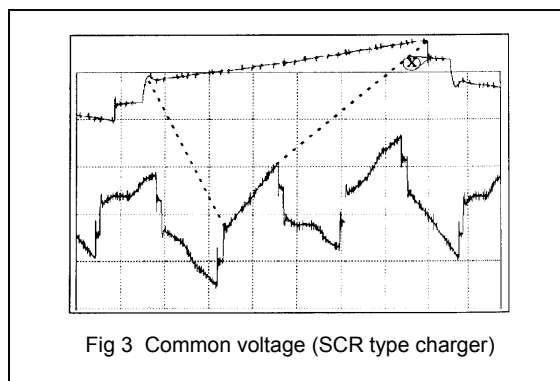
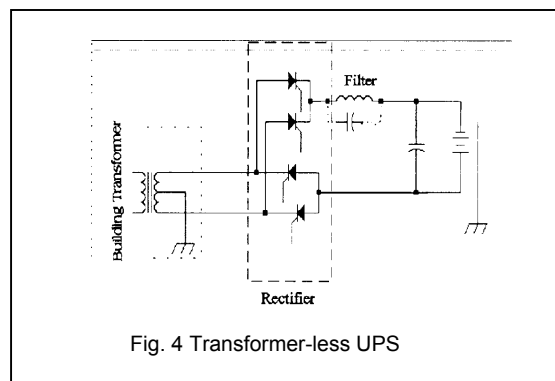
Note the presence of high frequency ripples along the straight line of the graph. These are the result of the PWM switching in the inverter. The high frequency components can be observed in the battery current as well. A similar shape and, surprisingly, amplitude can also be observed when the current probe is placed across the two conductors supplying the battery.

AC voltage of the entire battery string with respect to ground is referred to as the common mode. When the battery is enclosed in a cabinet, installations without an input transformer are permitted. In such installations, the battery will follow the potential of the incoming power line in unison with the switching charger device sequence and frequency. Since a 480 V power line is commonly used in such applications, common mode voltages on the battery installation may reach 400 V. The fundamental frequency of the common mode voltage may be as low as 60 Hz, but it can reach 120 kHz with considerable amplitudes present (Fig. 3).

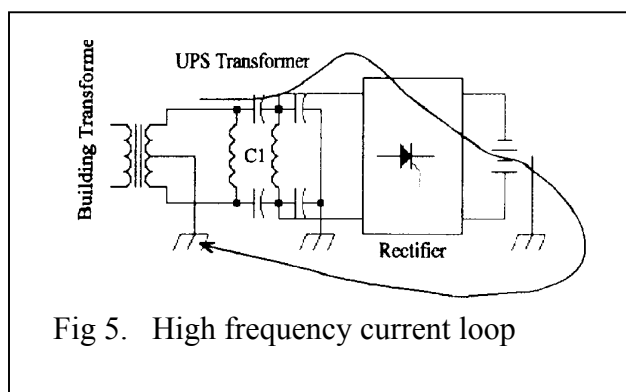
When the charger employs active switches however, high frequencies are generated and they find their way through C1 via common filters and inductance of the cables into the battery. The battery itself also has capacitance with respect to ground.

When an isolation transformer is used, one can expect that no DC or AC common mode voltage will be present. Although this is true for DC and, in most cases, for 60 Hz, it is not true when high frequencies are considered. The presence of high frequency common mode voltages can be understood when the high frequency model of the input transformer is considered. There will always be capacitance between windings in the real transformer (C1). If the transition of the conducting device occurs in soft mode (like in the full bridge, full wave rectifier), the output voltage will be free of high frequency components since they were not generated in the first place. When the charger employs active switches however, high frequencies are generated and they find their way through C1 via common filters and inductance of the cables into the battery. The battery itself also has capacitance with respect to ground.

Since there are many stray inductances and capacitances in the circuit, prediction of the magnitude and frequency of ringing after each switch event is difficult. It is also difficult to assess the magnitude of the high frequency ripple current passing from the battery to ground, through its casing. Up to 80 mA at 120 kHz was measured in installations of 120 cells

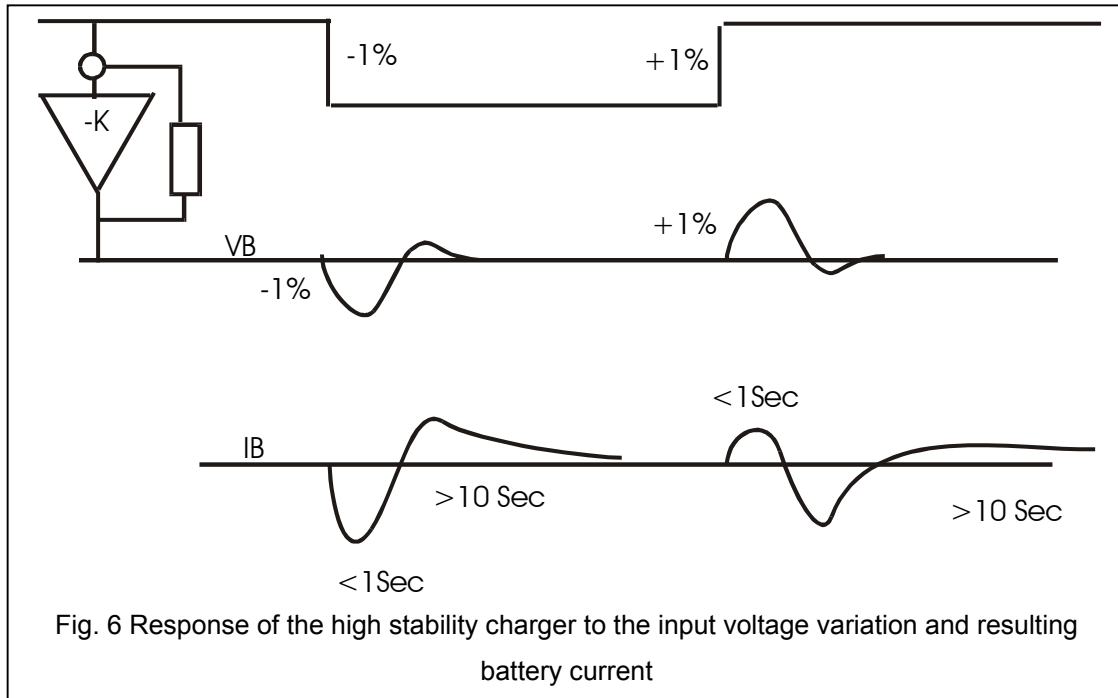
To explain fully this phenomena, we need to reach for closed loop tool analysis used for calculation of the stability of a high gain control systems This analysis is beyond the scope of this paper, however results of such presented in Fig 6. should be convincing enough. From this drawing it becomes evident that insignificant input voltage variation, which are not recorded by any power monitoring equipment, will produce the same effect as short duration shallow discharges of the battery. This is good news for battery monitoring manufacturers, since such events are quite frequent and the behavior of the battery under real load can be observed without any injection of the external load or current pulses [4]
