# Infobatt 2007

## The Science of Using Catalysts in VRLA Cells

Harold A. Vanasse – Philadelphia Scientific

Robert Anderson – Anderson's Electronics

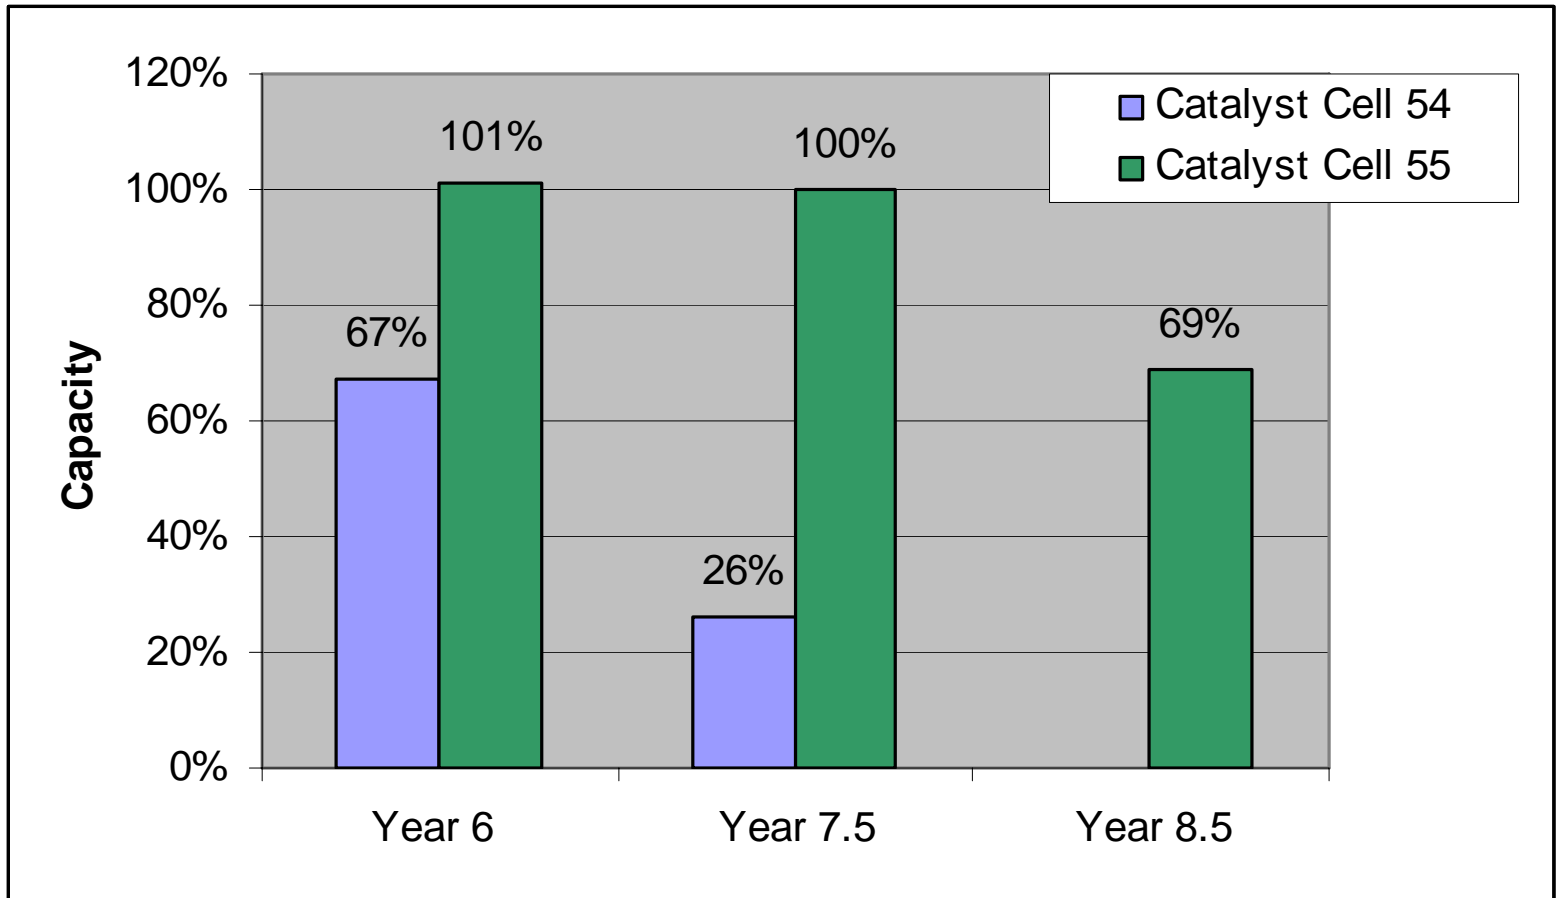
## Capacity Until End on 2 Remaining Cells

Note: 8.5 Years at 32°C is equivalent to 14 years at 25°C

- Year 7.5 one of two remaining catalyst cells fails.
  - Plates in excellent condition.
  - Failure was caused by positive strap corrosion.
  - Catalyst does not protect against this as it is a mechanical design issue.
    - Known defect of this design.
- Year 8.5 final catalyst cell fails.
  - Failure was caused by jar crack near positive post due to corrosion and growth of positive strap.
    - Known defect of this design.
  - This is equivalent to 14 years of life at 25°C.

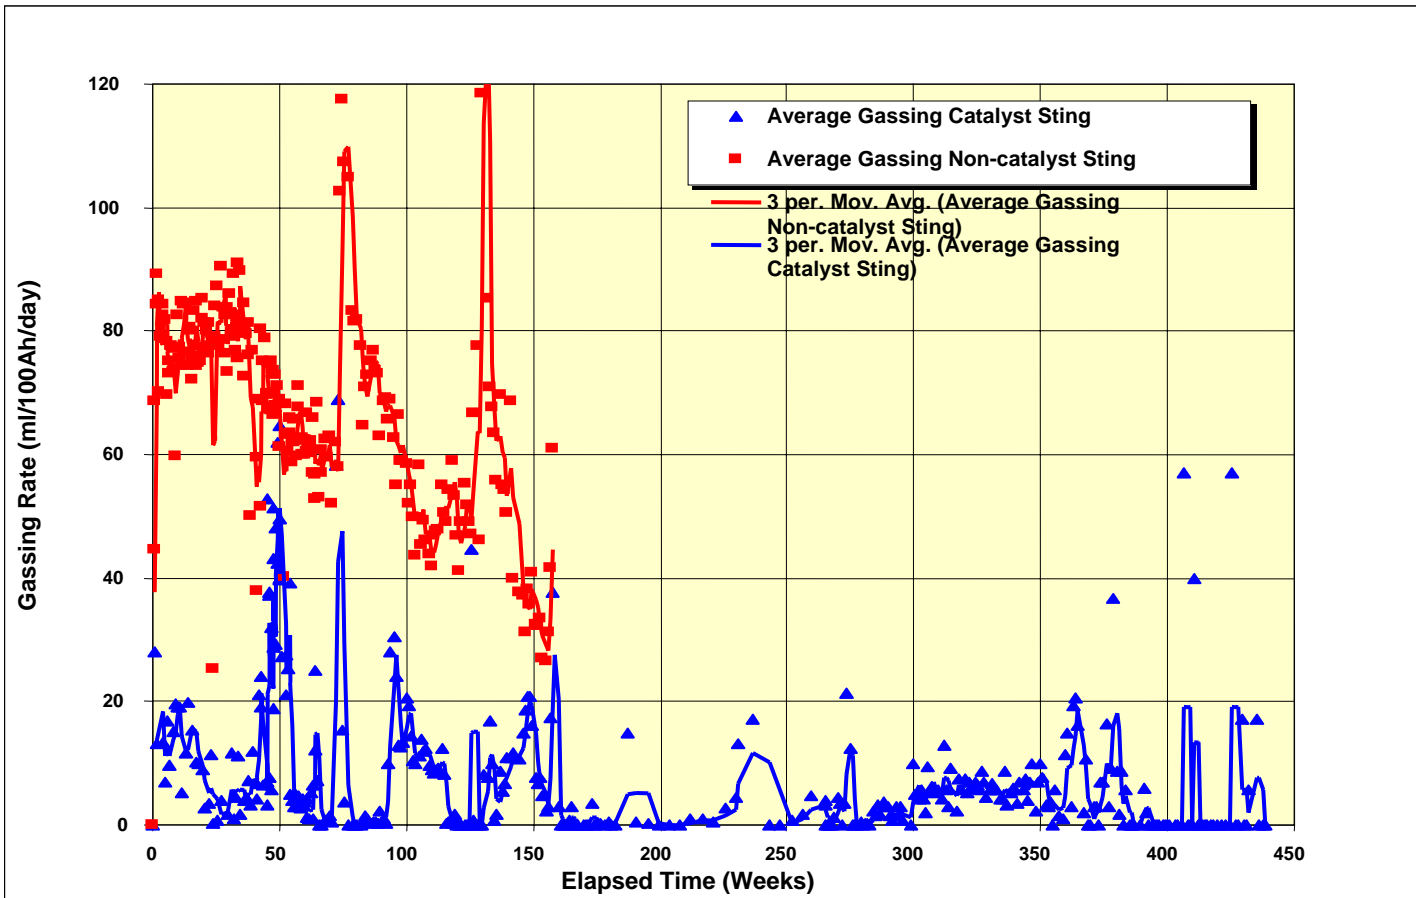
## 8.5 Years of Gas Evolution

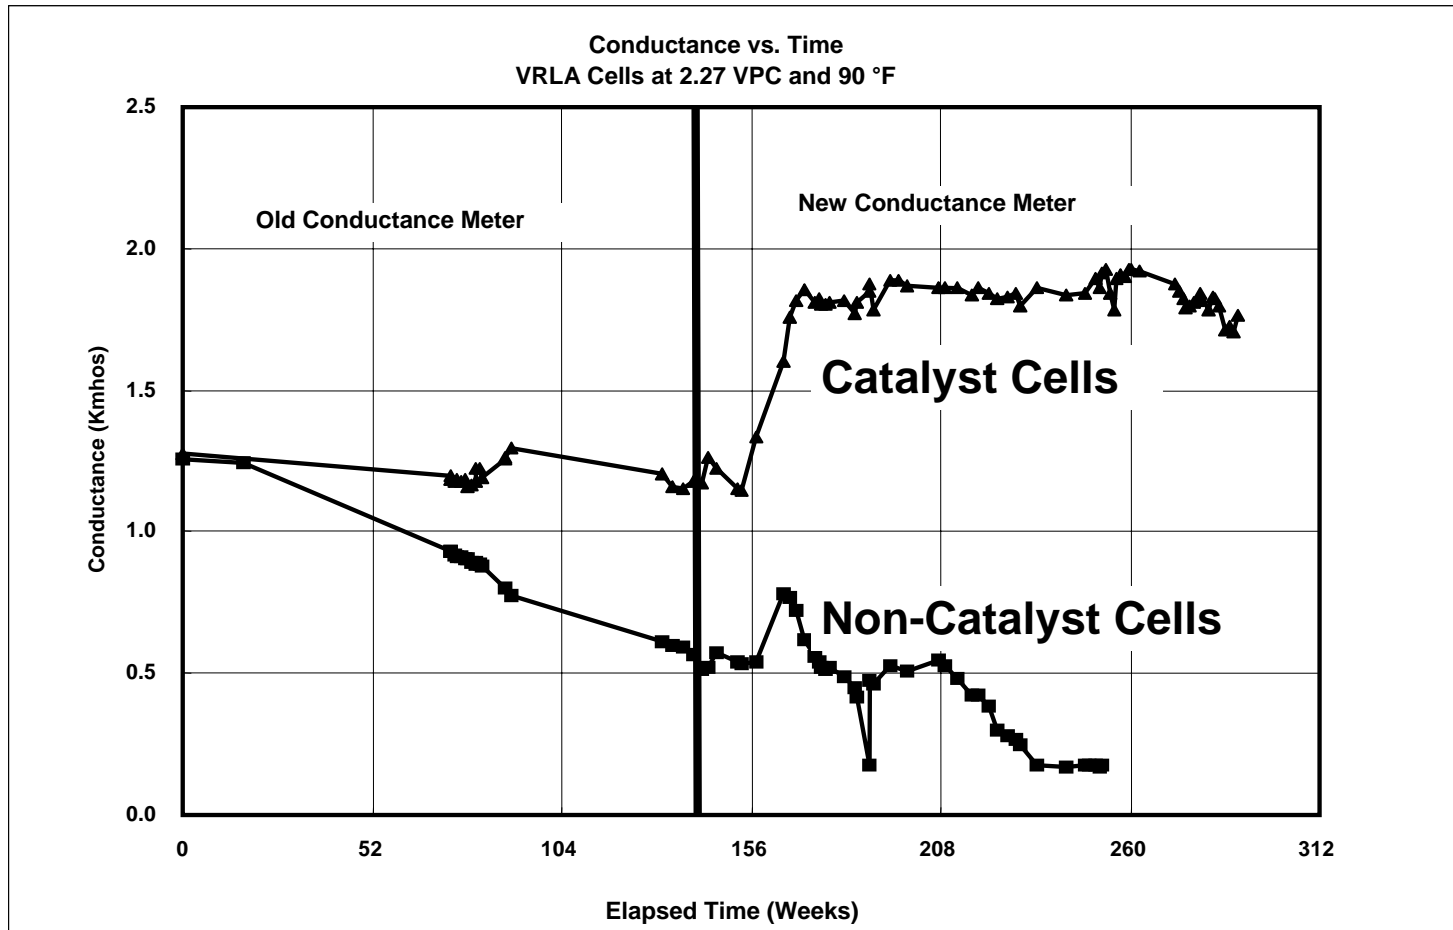
## Conductance

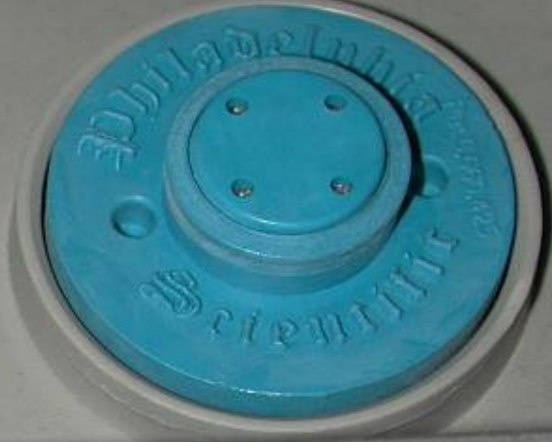
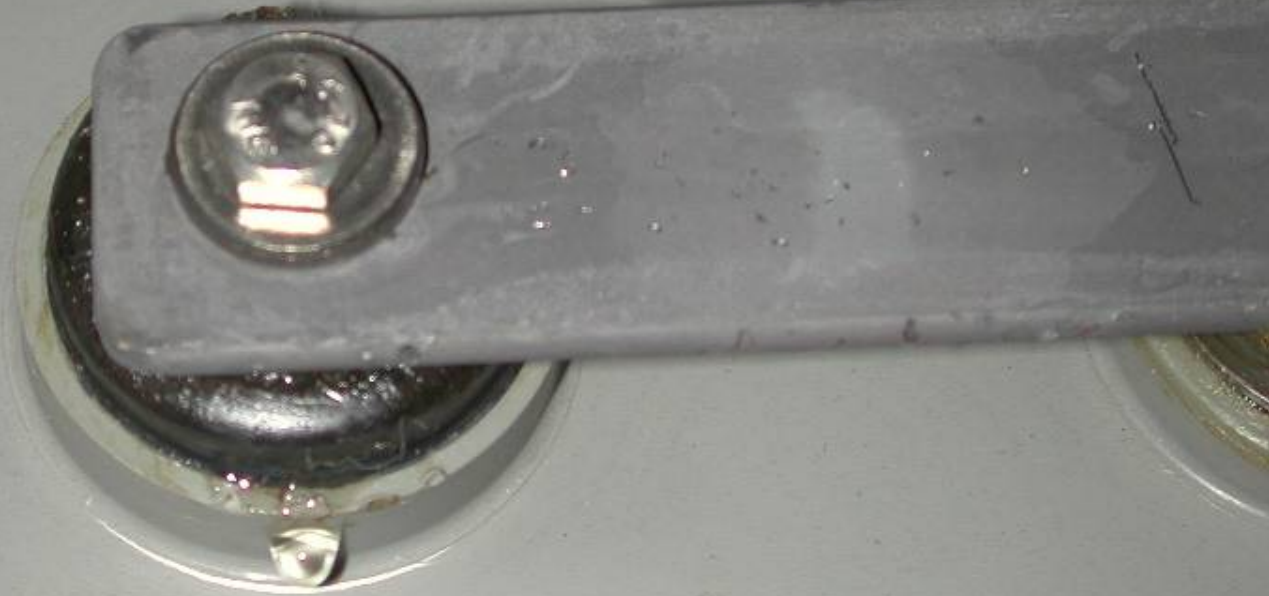
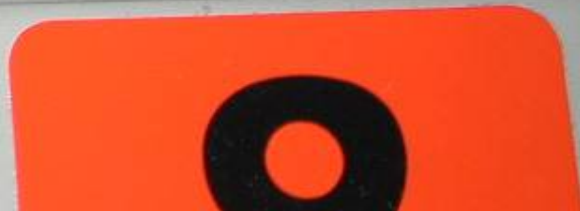
- Six years after the procedure a single post seal leak formed and the owner removed the string from the site.
  - This is company policy even though battery still maintained capacity.
- Positive plate growth had advanced enough to form white rings around some positive posts.
